Lakes & Ponds Project Profiles

Slope Stabilization Lakewood, OH

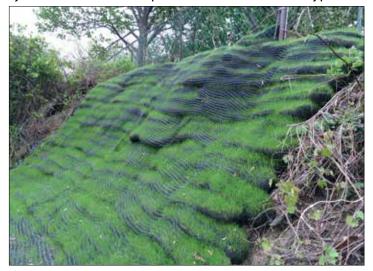
residential projects. They are easy to move into place and install without heavy equipment," said Nick Strazar, Inside Sales Manager for Filtrexx International. The team cleared existing brush and debris by hand, with no excavation required. The GroSoxx were pre-seeded with a mixture of perennial rye and native wild flowers.

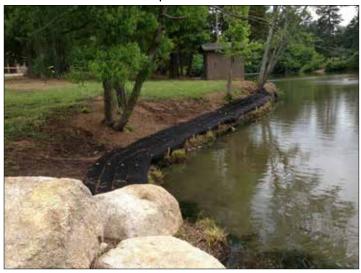
was aesthetically pleasing. They chose Filtrexx Bank Stabilization application, which uses GroSoxx and/ or geogrid to provide structural protection, control erosion, and establish vegetation in one simple system. The GroSoxx were vegetated with Eragrostis curvula, commonly known as Weeping Lovegrass. It produces an extensive root system that makes it useful for erosion control.

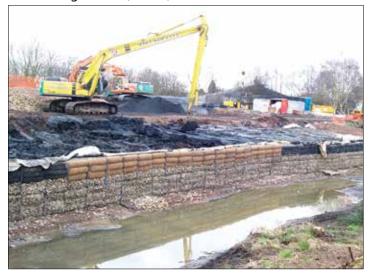
GroSoxx with MetalLoxx® additives were manufactured by Forth Resource Management to fill the gabions. There are numerous options to consider, from completely filling the gabion structure with GroSoxx to only filling the fascia portion next to the soil fill, which is decided upon by the site engineer.

Dredge material was placed over the wall of the Gabion structure, and then 'encapsulated' because GroSoxx prevent the movement of silt through the Soxx™, while also enabling vegetation to grow and excess water to filter through. A 'cap' of locally made compost was placed on top. The project had the best of all worlds–filtration, stabilization, and removal of heavy metals.

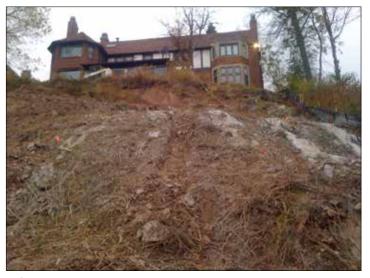
Before.

The new homeowners of a historic lakefront property had slope stability concerns as well as a desire to access the sandy beach at the water's edge. The project site is located on a 115 foot 2:1 bluff overlooking Lake Michigan. From the view from the back porch windows, the home was right at the edge of the slope. It was determined by the geotechnical engineer that the site required stabilization.

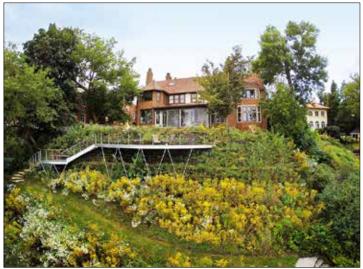
After.

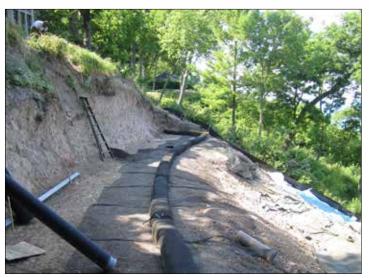
Installation of the GreenLoxx LivingWall

The 90-foot long by 15-foot high GreenLoxx® LivingWall™ consisted of lightweight geo-foam block

backfill material, soil anchors, and 3" galvanized pipe tied to layers of geogrid wrapped around every two layers of the GroSoxx® at the face of the wall.

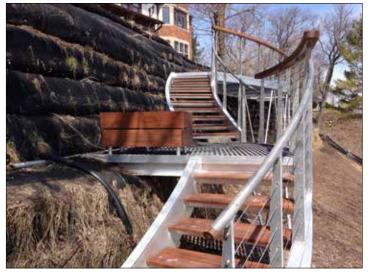
The GreenLoxx LivingWall (dormant here) is the foundation to which the deck and stairs are anchored.

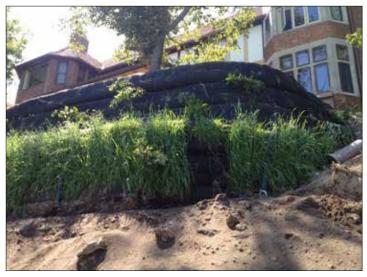
Construction of the upper wall is complete.

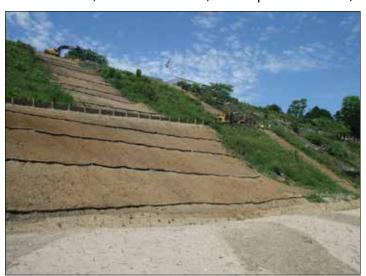
as well as for construction services. They used a multi-BMP approach that included Filtrexx slope interruption and a biodegradable turf reinforcement mat. Marek installed 8″ degradable SiltSoxx™ secured by hardwood stakes every six feet. They used laser levels to place them horizontally along the contours of the site every eight vertical feet. The media was a blend of FilterMedia™ and GrowingMedia designed to both slow the pass through rate and increase infiltration to the soil, thereby reducing runoff and encouraging plant growth. The entire slope was then seeded with a mix of mesic prairie plants, specifically selected for the site's slope aspect and soils. Marek has

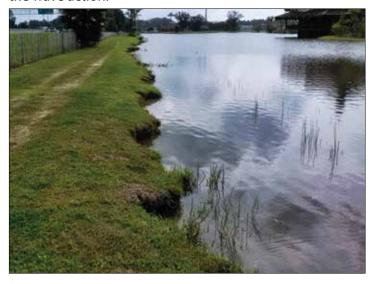
This lake bank was rebuilt with GroSoxx because they are aesthetically pleasing and offer proven performance—at a fraction of the cost of hardscape. GroSoxx, filled with Filtrexx GrowingMedia™, provide a stable and fertile environment for optimum vegetation establishment.
