Living Shorelines

Beaches & Oceans
Project Profiles

Dune Restoration

Stratford Point, CT

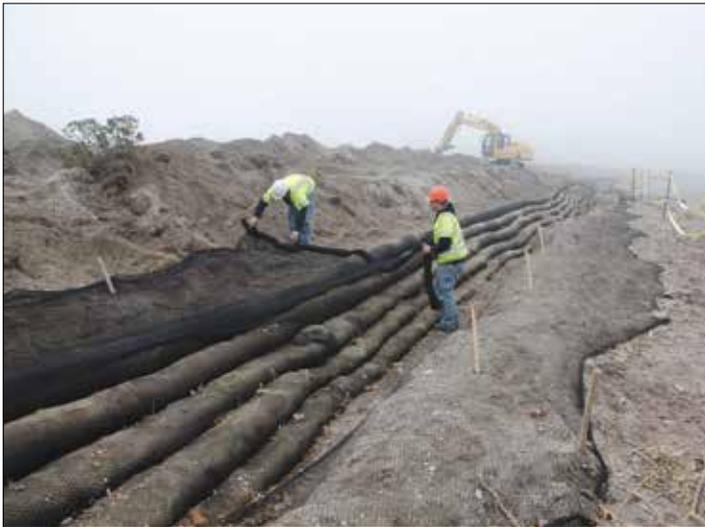
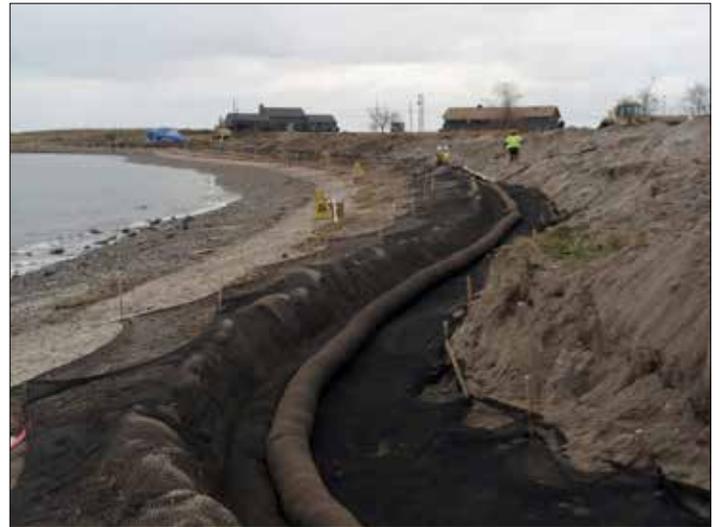
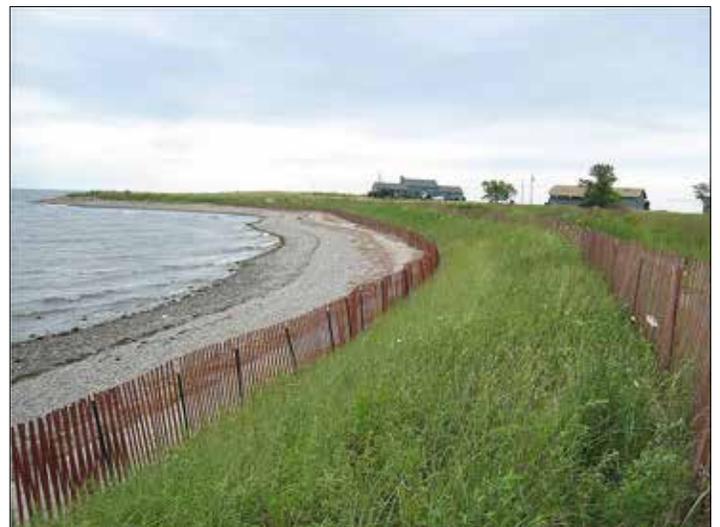
of our dune remained intact and the shoreline relatively unaffected. Our dune remains a key part of the ecosystem protection and restoration at Stratford Point."

by hurricane Irene had left the shoreline badly eroded. Landowners worked with the Connecticut Audubon Society, specialty contractor All Habitat Services, LLC, and CEC Connecticut to restore the 900-ft coastal dune system. The team modified Filtrexx Bank Stabilization system, filling 12" SoilSoxx® with a compost and sand mixture reinforced with geotextile. The SoilSoxx were covered with a thick layer of sand and planted with 38,000 American Beach Grass plantings to form an artificial coastal dune system extending the length of the north shore. The entire structure is designed to match the height of the existing bluff. The Soxx are invisible from view, but provide stability to the entire system.

According to All Habitat, "During Hurricane Sandy, the dune aided in prevention of major erosion of the shoreline and other inland areas. Although the storm washed away the dune's sand and vegetation, the base

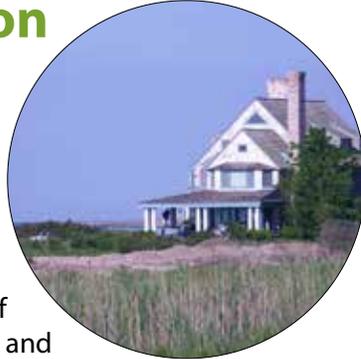
In 2010, dunes along the Katharine Hepburn former estate historic landmark were renovated using dredged material from the salt marsh nearby. The area was subject to concern due to a thin amount of beach dune between the ocean and the salt marsh behind Old Saybrook.

These areas are common along the East coast, and often concerns for breaching of the dunes during surge events leads to restoration efforts to prevent loose sands in dunes from moving.

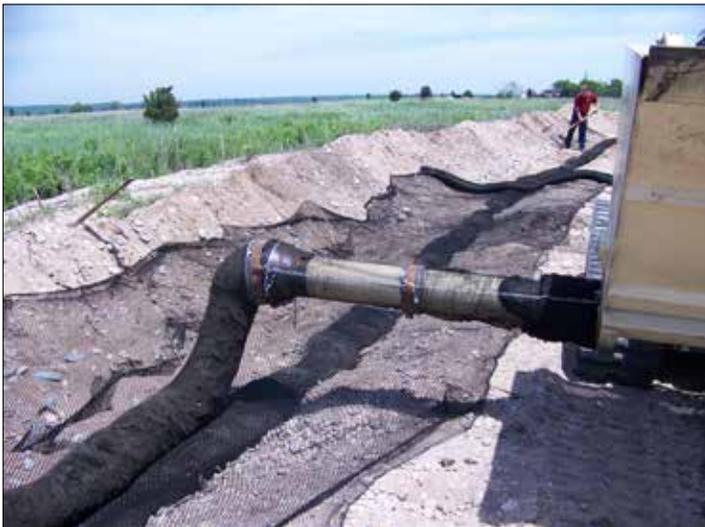
The project was coordinated by having mobile equipment on site (Filtrexx FX Machine and a track loader) and being able to use local dredge materials to fill the 12" Filtrexx SoilSoxx®. The dredge was a suitable combination of sand and organic matter depositions, allowing for it to

be used as a growing media for salt tolerant plant species. The dredge material had previously been excavated and left on site to naturally dewater over time. When used, it was at normal atmospheric conditions, in various piles around the targeted job site. Small bobcat loaders

were used to move the dredge and prepare the area to place the filled Soxx. The FX Machine was able to fill several hundred feet of soxx per run. Each layer of Soxx were wrapped in a lightweight reinforcement geogrid to keep the layers from moving upon tidal impact. The successive layers were filled and stair stepped back to an approximate 3:1 slope. Each layer of lightweight geogrid extended several feet back into the slope, buried from the successive layers on top of them. Once the Soxx were filled and the new face of the dune restored, they were planted with a variety of salt tolerant species of plugs, which immediately began to grow and thrive.

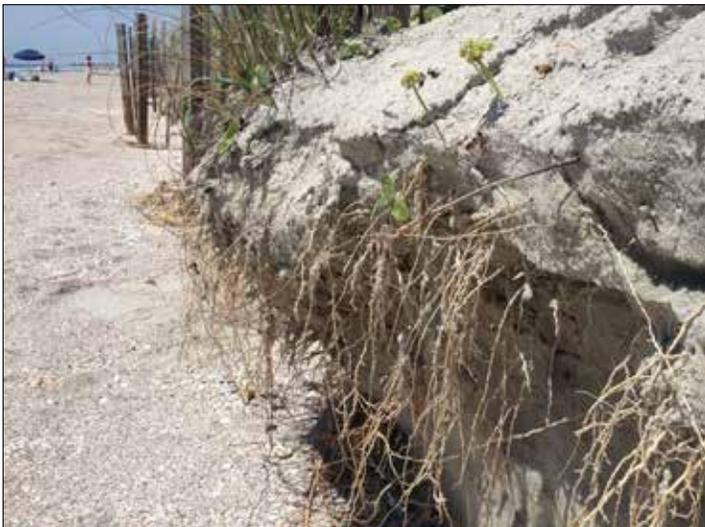
Before

Dune scarp prevention is a new practice and design consideration among beach dune restoration and preservation efforts. Loose sand that accumulates within sand dunes is mixed with vegetation, and ideally, becomes large mounds, however there are still difficulties in holding together loose sand during tidal surge events. Full moons, large tides, storms, and hurricanes cause surge events, especially if at high tide, that often cause irreparable damage to dunes that have taken years to accumulate. When dunes begin to erode from the ocean side, the edge of the dune becomes scalloped out and is scarping with each tidal event. Each wave that continues to pound loose sand loosens the non reinforced dune, dislodges vegetation, and erodes the face of the dune. The scarp is normally nearly vertical because the sand continues to fall into the surf when the toe of the dune is washed away with each subsequent wave. As this process continues, the dune scarp becomes more and more into the center of the dune, and greater amounts of sand are washed away with each successive wave and tidal event.

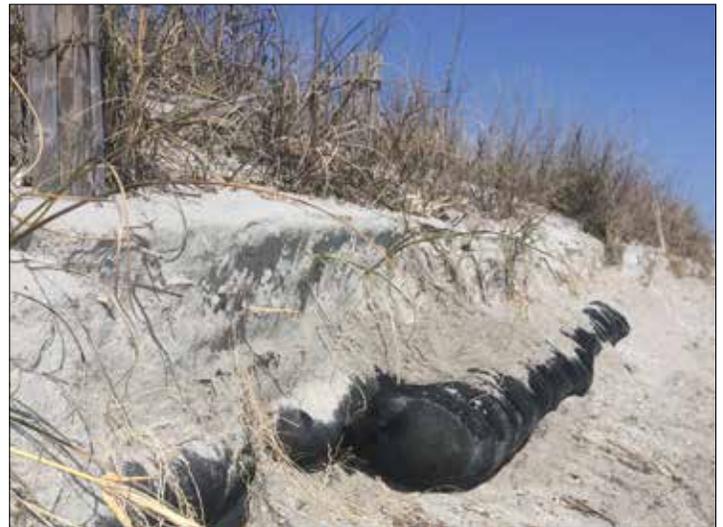
Installation

By utilizing a design concept of preventing this scarp from worsening, Filtrexx placed a SoilSoxx® at the toe of the escarpment along the face of the dune. This location is where the waves meet the dune, upon high tide. The Soxx were filled with native beach sand on location. Care was taken to ensure the mesh openings were small enough to encapsulate and contain the fine sands of the South Carolina beaches. Various sand conditions exist and if the sand is able to rinse out of the Soxx, limited protection would be provided. Filtrexx has over a dozen different selections of mesh to fit the needs of various grain sizes of sands for beach dune scarp prevention. Once the Soxx were filled, they were covered with a light layer of sand to blend in with the rest of the dune structure.

The next tide event brought even higher tides. Within one full tide, the Soxx not only prevented dune scarps from further progressing, but they assisted in sand deposition next to the toe of the dune, and eventually buried the Soxx in the dune toe, thereby further preserving the dune for future events. During the next low tide, another Soxx was filled directly on top of the first Soxx. **Continued...**

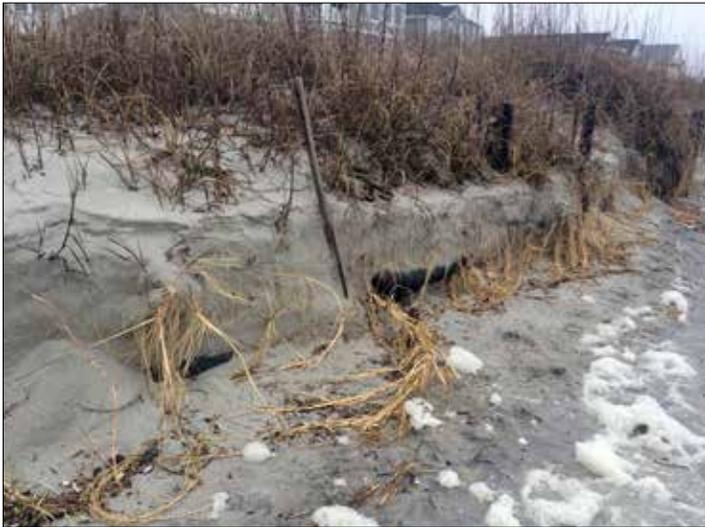
After storm surge (1 year)

Continued... It was clear that the beach had gained significant height in a storm surge and sand accumulation was happening. The installation of the Soxx prevented dune scarp during these events, and led to protection of the dune into the following year. Nearly one year later, during a similar storm event, the toe of the dune began eroding away (below). As the toe of the dune began to regress further and further into the dune structure, eventually the original Soxx from one year earlier were unearthed, and then continued to provide protection against further dune scarp. Note, the vegetation that had grown partially into the Soxx over one year had more success in resisting erosion from tidal events than those plants without Soxx.

The minimum size of Soxx to be considered for dune scarp protection should be 12" in diameter, filled with native beach sand, and filled to a continuous length of at least 25 feet. If possible, continuous lengths of several hundred feet will be less likely to move during severe storm events. The use of lightweight geogrid wraps can also be considered, during the dune construction process, and this practice allows dune scarp prevention to be part of a future preventative planning process for responsible dune management.

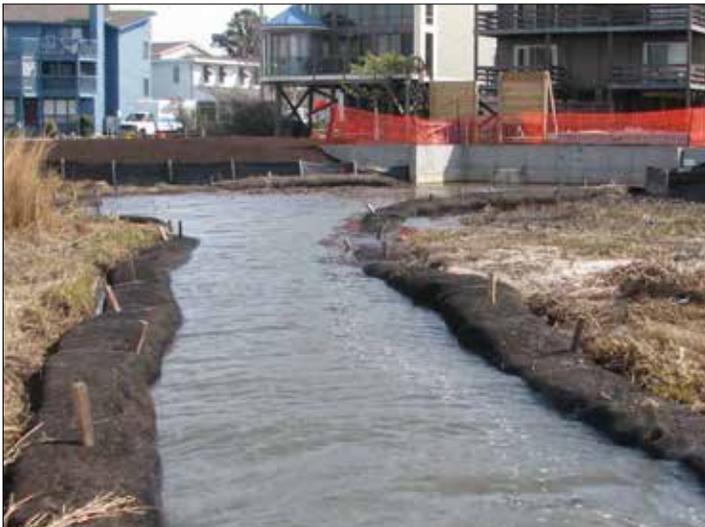
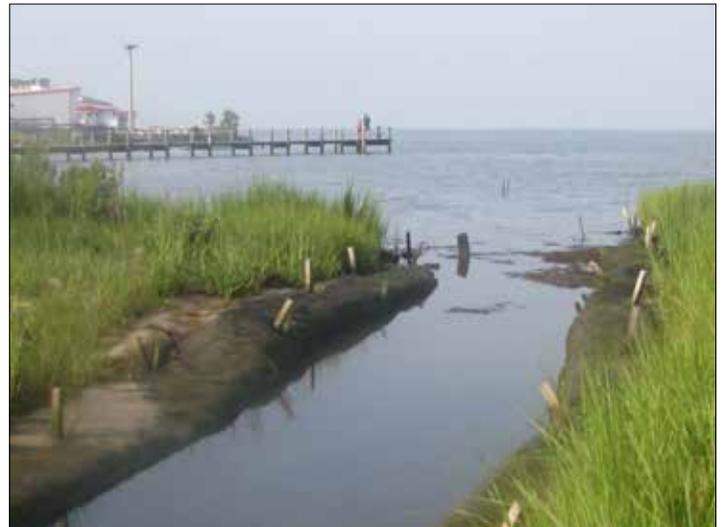
located within the wetland were removed and a stream channel was created in their place. They created a drainage swale and stabilized it using Filtrexx Bank Stabilization made with 24" Soxx™. The effect was 100% performance. Zero flooding has occurred within the watershed since construction was completed in April 2011 (except for flooding caused by a pump failure in 2012). The system even withstood the impact of Hurricane Irene in August 2011.

Envirotech Environmental Consulting, Inc. was retained, in conjunction with ECI Engineering Planning Surveying, to create a Green Technology BMP for low impact development and coastal watershed management. The plan included road grading, additional catch basins, a berm with an outfall structure pumping station, and a drainage swale. The berm was created over an existing bulkhead, and stabilized with Filtrexx® Compost Storm Water Blanket™ with Lockdown™ Netting and native vegetation. Outfall pipes convey water into this dissipation area. The existing non-functioning pipes
