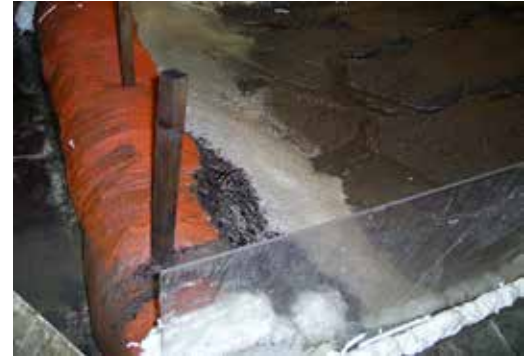
were installed on a loamy sand soil at the base of a 3:1 slope with an exposed soil and drainage of area of 2 meters wide by 8 meters long. The design storm utilized for this research project used a Norton Ladder Rainfall Simulator developed by the USDA ARS National Soil Erosion Research Laboratory and was programmed for an intensity and duration of 2 in (5 cm)/20 minutes followed by 4 in (10 cm)/30 minutes. Average peak runoff rate exposed to the sediment control barriers was 28.4 liters/min, average runoff volume was 986 liters, average sediment concentration was 460,000 mg/L, and average sediment load was 385 kg. Experimental runs were conducted in triplicate to obtain statistical means.
