Living Shorelines

Rivers & Streams
Project Profiles

Streambank Stabilization

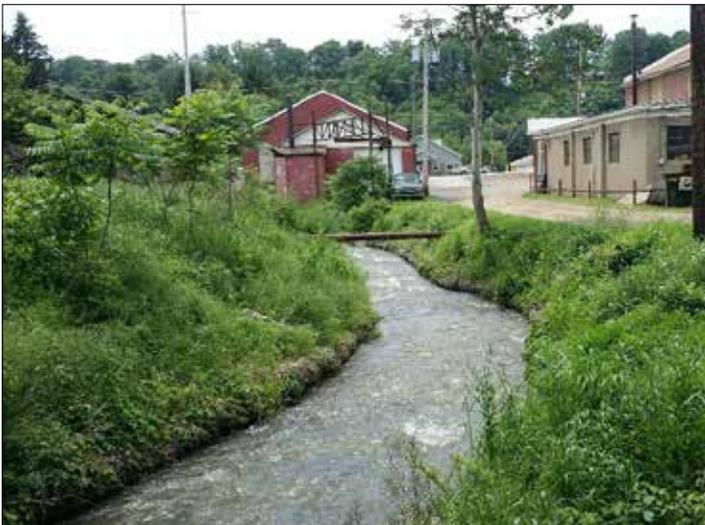
Filtrexx often partners with engineers for custom installations, especially when working with engineers who are still familiarizing themselves with the product and all its potential variations. Kevin Weaver, CPESC, and VP of Business Development for Filtrexx International, conducted a Lunch & Learn with an engineering firm in Jefferson County, PA, who were engaged in a streambank restoration project in the Punxsutawney area. Wanting to move away from the use of concrete and rip rap, the engineers saw Filtrexx vegetated GroSoxx® technology as a path toward a more bioengineered solution. Weaver assisted the engineer during the planning phase to create a sustainable and eco-friendly solution to restore the streambank. The plans incorporated Filtrexx GreenLoxx® with a mini-gabion foundation. "Blending the two systems worked very well," said Weaver. "There was no need to use a vegetated GroSoxx under the water, and the gabion lends additional strength to the whole system." The team also installed drip irrigation in the GroSoxx to ensure good germination and long term plant health—a hallmark of Filtrexx LivingWalls.

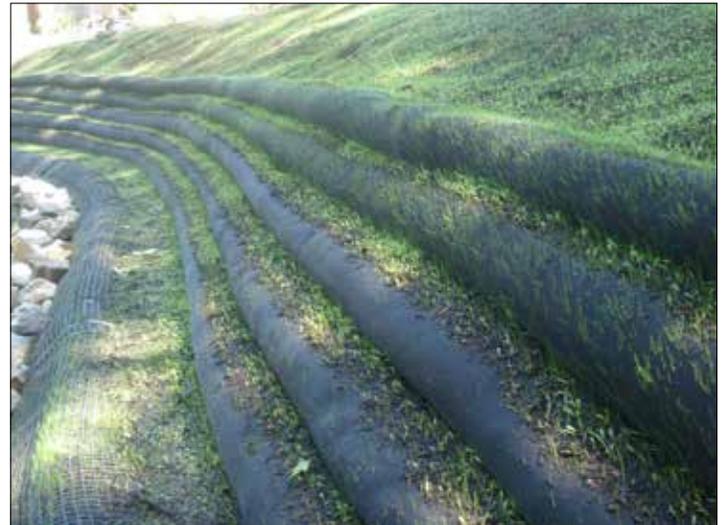
A homeowner contacted Filtrexx because a stream in their side yard, which usually runs at a trickle, had begun swelling to a three to four foot river after each rain event. Each event washed away a significant amount of land—initially just a foot or so per year. When one month's rain took five or more feet of land and brought the eroded bank within 15 feet of the home's foundation, the homeowners decided it was time to do something.

A local Filtrexx Installer engineered a solution to accommodate the stream's highest flow, yet was still attractive during dryer months. The team used 12" Soxx™ to create stepped "flood zones" to minimize erosion, stepping up two feet and back three feet for each level. Above the flood zones they created a LivingWall™ pre-seeded with a deep root grass mix and a wildflower erosion control mix. The solution restored what had been lost to erosion over the previous 20 years.

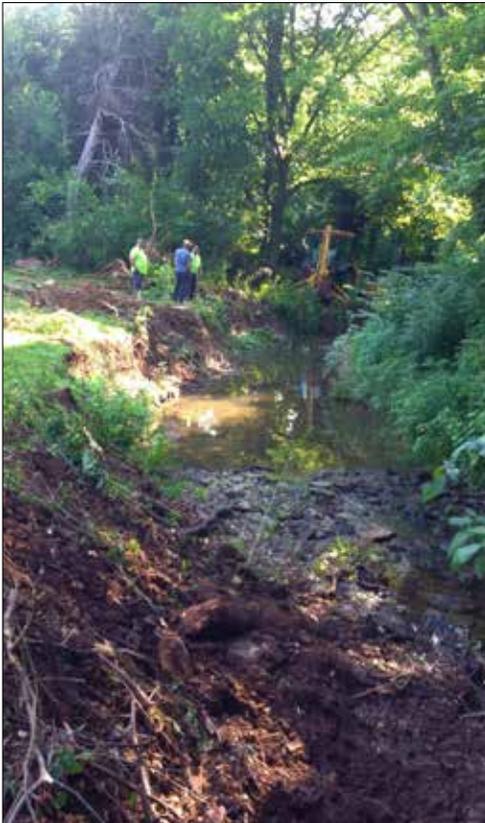
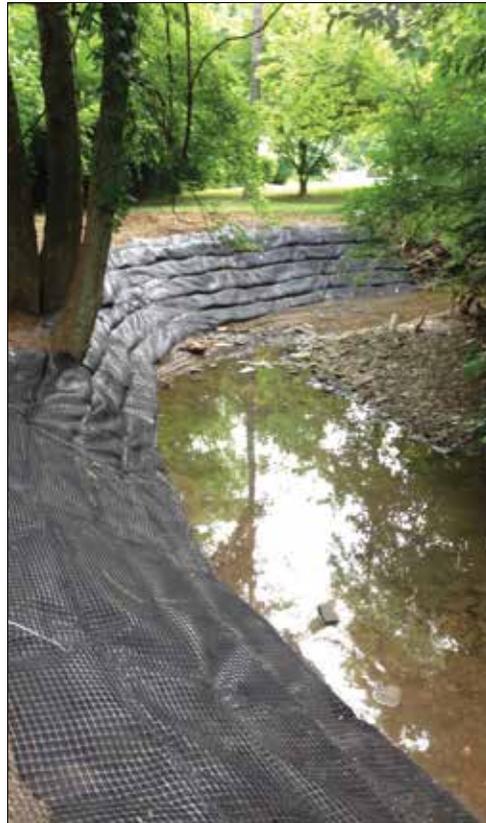
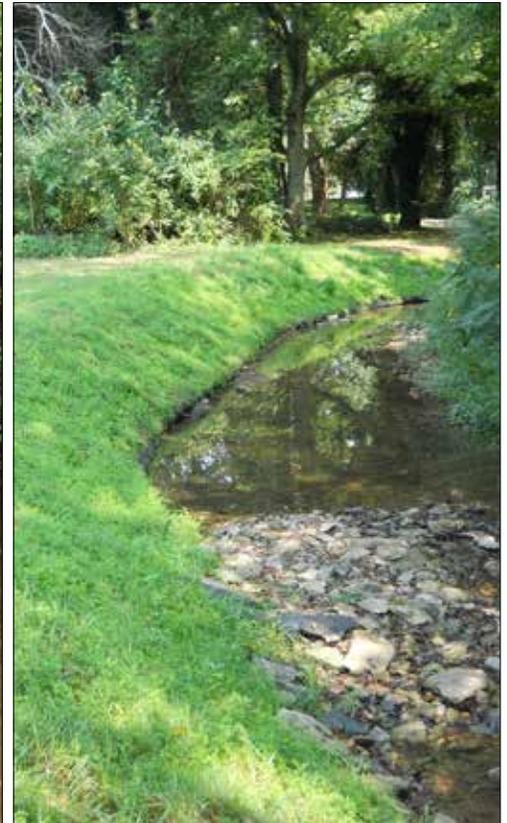
Continued... Mid-TN showed them several installations that use Filtrexx® Bank Stabilization technology and they were very impressed with the rapid and sustained vegetation and their overall stability under the constant flow of water.

"We conducted a cost analysis and found that the labor was not drastically different from what we had used in the past, but this system lasts a lot longer," said Richardson. TDEC approved the City's proposal to use Filtrexx® Bank Stabilization technology to mitigate the loss of land. This technology uses GroSoxx® filled with engineered Filtrexx® GrowingMedia™. GroSoxx® are typically pre-seeded with native species for successful establishment. On this project, the GroSoxx® were seeded with switchgrass, hairy vetch, fescue, and bermudagrass.

Mid-TN Erosion stabilized a 530-foot section of bank, at an average height of four feet. "It took six men about a day and a half to build the product and a day and a half to install it," said Chris Richey, of Mid-TN.

GroSoxx® are installed in successive courses along with geogrid to provide structural protection, control erosion, and establish and reinforce vegetation all in one simple system. The application has been specifically developed to withstand high flow velocities and shear stresses that conventional products cannot withstand. Over time the vegetation creates a natural anchor between the bank and the stabilization system. We call this "nature's velcro". Eight weeks later, the GroSoxx® have indeed proven to be effective. "I was out there last week and it was unbelievable! You can't see the mesh—it's completely vegetated," said Richardson. "And the homeowners are tickled to death, it looks like their lawn extends right up to the bank."

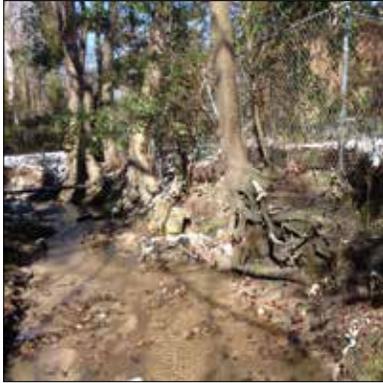
in some locations, and a design that would also look very natural," said Allison Steele, Stormwater Engineer for Richland County. "The whole point of the project was to give them their yards back." Engineering firm CDM Smith decided to use Filtrexx GreenLoxx LivingWall, not only for its verticality, but also for its ease of installation in a forested environment. The GroSoxx used in the GreenLoxx LivingWall mold to fit around trees, eliminating the need to clear cut. Filtrexx® CertifiedSM Installers Eco-FX, Inc.

(Charlotte, NC) and Coogler Construction, Inc. (Ballentine, SC) teamed up for the custom installation. Together they installed approximately 600 feet of streambank, and the work was completed in about two weeks. GreenLoxx can be installed with or without mechanical reinforcement. This project used both. The Soxx were pre-seeded with an annual cover crop. The team returned this spring to plant several hundred native plants for permanent stabilization

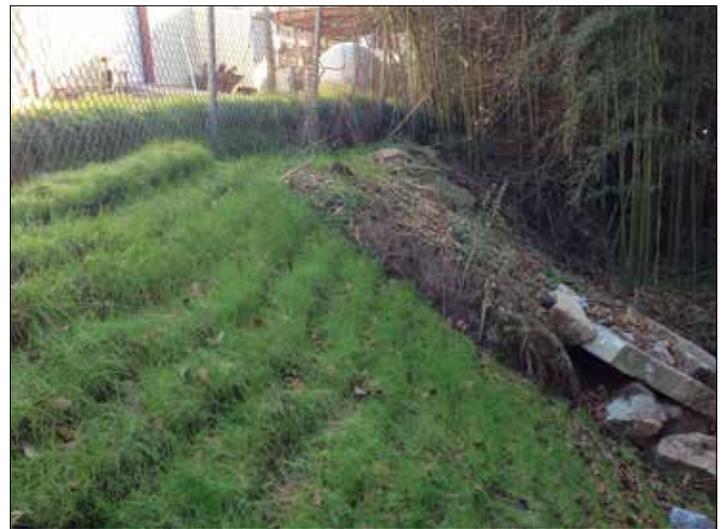
The Clemson University campus is bisected by Hunnicutt Creek. A small but steep bank along this creek had been steadily eroding. Land Planning Associates, Inc. in Easley, SC provided a plan to stabilize the bank using GroSoxx®. Company engineers saw this as a good opportunity to try the product on a small scale. McJunkin Grading installed 12" GroSoxx in a pyramid stack at the top of the slope to divert water to an inlet, while using 8" GroSoxx on the slope itself. "We had used Filtrexx for sediment control in the past, but we had never used the GroSoxx. They were very easy to install," said Kevin Ross, Civil Engineer for McJunkin Grading. LPA Project Manager Allan Fortner was extremely pleased too. "They work fantastic. They did everything we expected and more. We installed the GroSoxx last fall and they are still holding up great after winter.

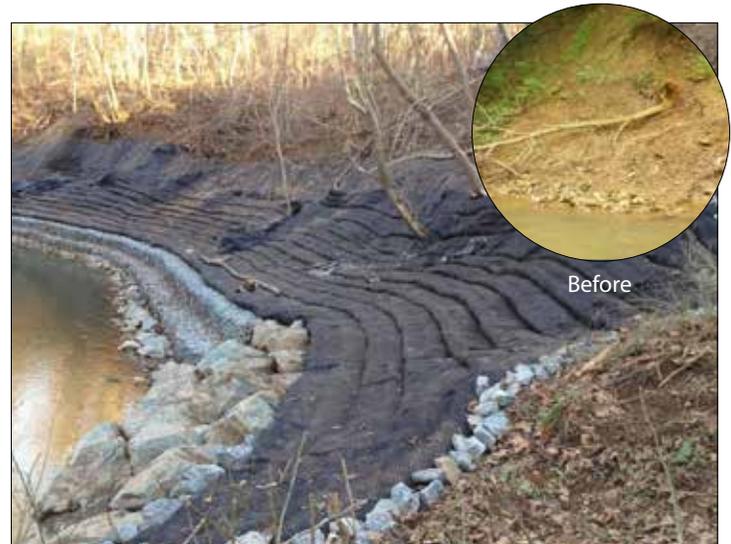
After reviewing hard armor and green alternatives for stabilizing the slope, the Filtrexx® LivingWall™ concept was selected. Filtrexx provided the design with assistance from The Earthworks Group (Murrells Inlet, SC) and Koth Consulting, P.C. (Powhatan, VA). The design consists of 180 feet of riprap filled gabions founded in the stream bed, extending approximately six feet above the normal stream flow elevation. Above the gabions are four rows of 18-inch diameter seeded GroSoxx® at the base, followed by 12-inch diameter GroSoxx® placed up to the 100 year flood stage elevation.

Commission and Albemarle County, VA. To create a dry work area, stream flow was diverted using an Aqua-Barrier® inflatable dam immediately upstream and pumps were used to discharge the impounded water downstream. Trackhoe and loader equipment were used to shape the slope as necessary before placing a geotextile blanket on the slope surface. After preparing the gabion subgrade, riprap was poured from above the slope into a chute connected to a "rock box" at the toe of slope. A loader removed the riprap and placed it into individual in-place gabion baskets. Once the gabions were completed, Yard Works used a blower truck located above the slope to fill the Sox^x™ with compost. Filtrexx® Lockdown™ Netting and duckbill anchors installed on 8-foot centers were used to secure every two rows of Sox^x. Once the Sox^x were installed, live stakes and plantings were set on 2-foot centers into the LivingWall. The wall was completed to approximately two feet above the 100-year stage. Since the slope was essentially vertical the final two feet, it was finished with either 8-inch Sox^x or live stakes.

The LivingWall was completed in March 2014. During construction and since completion of the LivingWall there have been six 1.5 to 4-inch rainfall events. The LivingWall has performed as intended during the six high stream flow events.

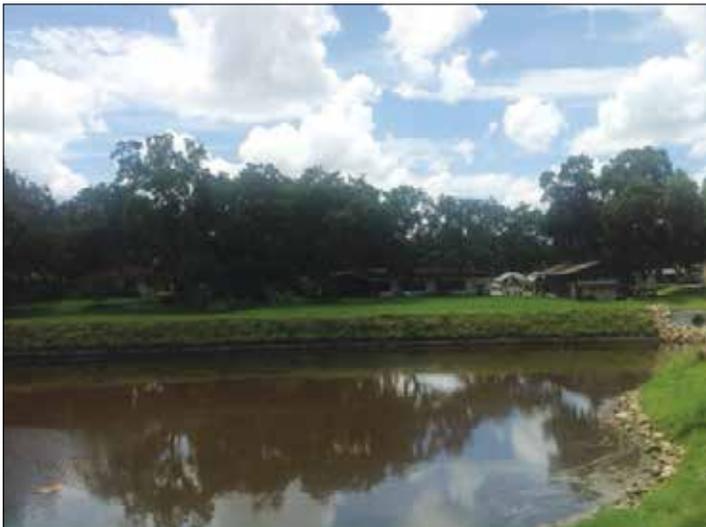
As part of a \$2.5 million sediment management project, Sarasota County has implemented the Phillippi Creek water quality improvement program. The Phillippi Creek Basin drains 57 square miles of Sarasota County. GroSoxx® Gabions were identified and selected as a critical component for the project. The gabions are used to both stabilize the banks of Phillippi Creek and to remove particulate matter and nutrients from surface runoff and filter lateral movement of water in the soil that drains into the creek. EPA acting assistant administrator Nancy Stoner visited Sarasota County to determine which projects could be replicated in other areas of the country. Overall improvement to Sarasota Bay attracted Stoner to the area however, her focus was on Phillippi Creek, a tributary that, despite its 60 percent reduction in nitrogen pollution since 1988, is still in need of much help. Said Stoner, "There will be a lot of interest in what people have done here and how it worked to restore these water bodies."

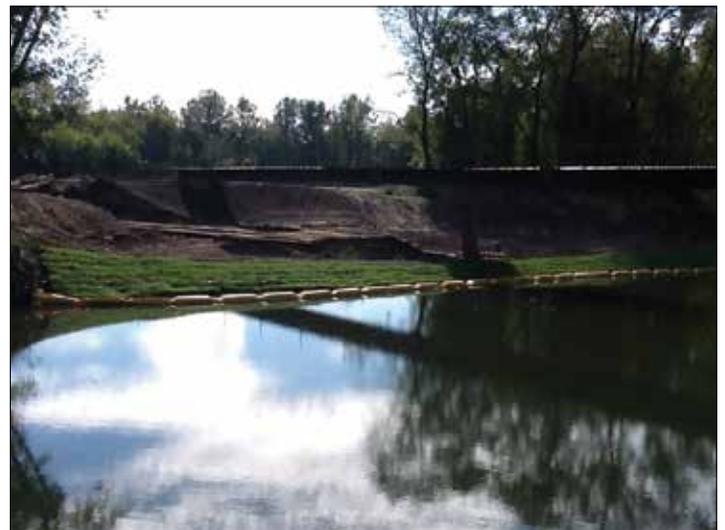
Gresham, Smith and Partners worked with Filtrexx to design a vegetated solution using Filtrexx® GroSoxx®-3' sections of Soxh™ pre-seeded for rapid and sustained vegetation that stop the loss of sediment and prevent erosion post-construction. Mid-TN Erosion Control installed the GroSoxx®, which were pre-seeded with turf seed. It took five men only one and one-half days to install the GroSoxx® along a 150-foot stretch of streambank. The seed germinated within five days of installation, and was fully vegetated within two weeks.

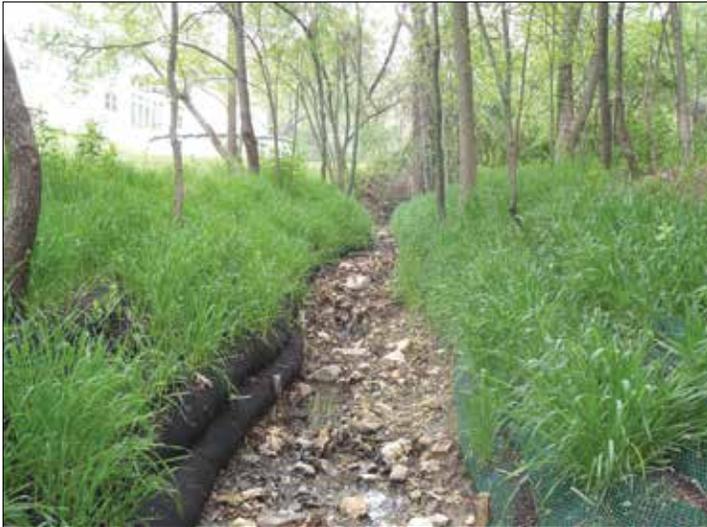
The city of St. Peters, Missouri has some 150 miles of streams and creeks that flow through it. The trees that line the Margaret Brown Creek had grown large and been encroached on by wild honeysuckle. A 16" culvert pipe that runs under a utility easement had been plugged causing the creek to overflow and cut an expanded channel.

ECO Constructors of Lake St. Louis was asked to help design a green solution to stabilize the creek. They corrected the overflow issues with a plug safe inlet extension and the creek stayed in its channel through the fall 2011 rainy season. The banks of the creek were then cleared of problem vegetation and reshaped using a mini-excavator. The sides of the creek were then repaired using the Filtrexx Bank Stabilization design and practices. During the installation, the Soxx™ were seeded with Virginia Wild Rye and plugged with live willow stakes.

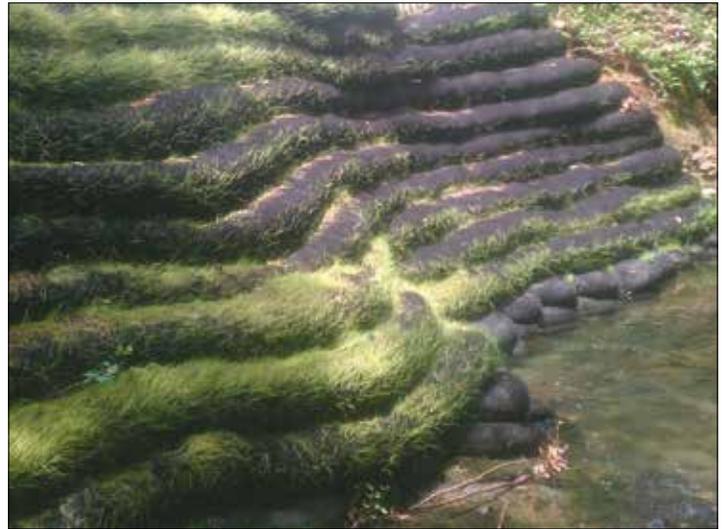
This streambank behind a residence in Charlotte, NC had been subject to increasing flows and velocities of water due to upstream construction over a period of several years. The owners had begun to lose their fence at the top of the streambank, and were at risk of losing part of their yard and turned to Eco-FX Environmental in an effort to save their land. Eco-FX installed the Filtrexx® LivingWall™ with minimal excavation, and all site preparation was completed without heavy equipment. Sections of 12" Soxx™ were filled with rock and used as the foundation of the Filtrexx® structure. After several major rain events, the structural integrity of the LivingWall™ is still intact and germination is occurring at an excellent rate.
