PROJECT PROFILE

PROJECT: RESIDENTIAL CANAL

APPLICATION: BANK STABILIZATION

PRODUCT: GREENLOXX® NON-MSE

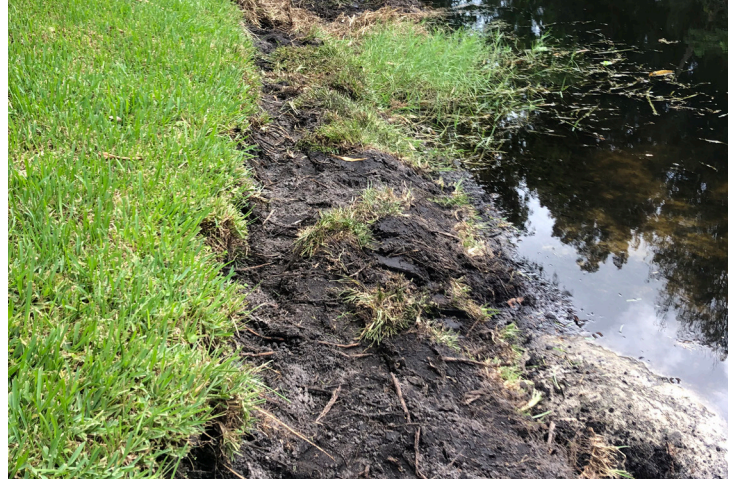
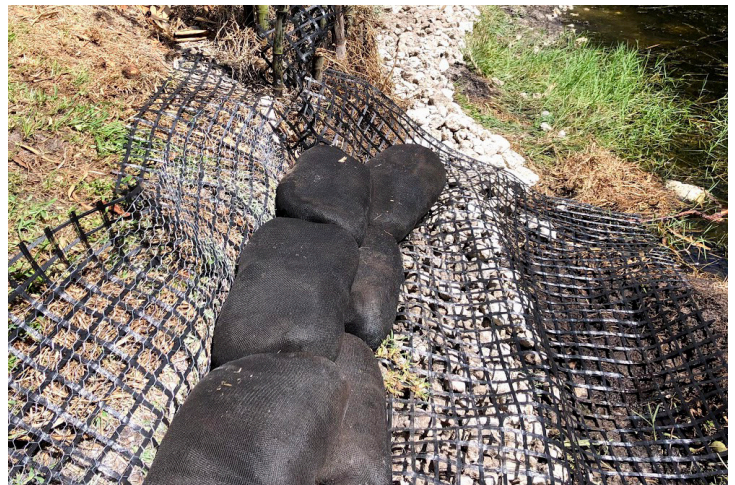
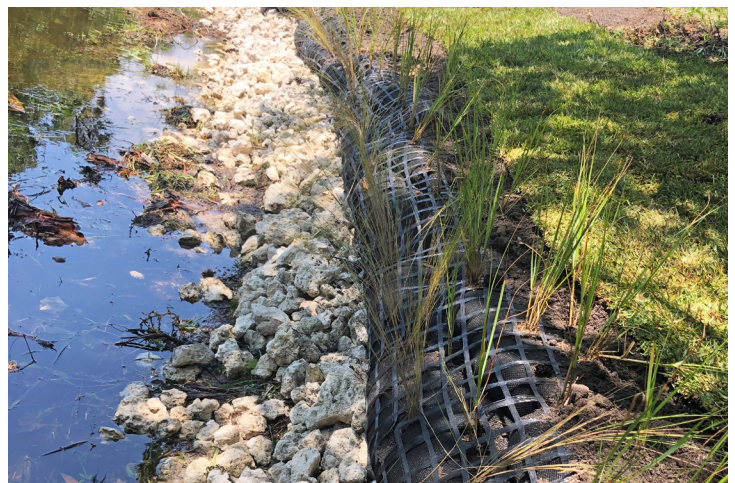
Solution: Filtrexx came down to inspect the site with Monster Tree Services and determine the best approach. Filtrexx helped install a GreenLoxx non-MSE Living Wall system that was flat enough that the turtles could still climb up the slope and into the backyard. Because the base of the canal was soft and muddy, native limestone was placed at the base of the wall. This limestone base was created so the wall had something sturdy to sit on top of. Then, 16-24" of wall was built out to stabilize the slope, stopping the erosion and preventing further erosion from happening. Trees and other vegetation were in danger of falling into the canal due to the severe erosion and all were saved and incorporated into the new wall system and landscape.

Success: The final, finished wall was 130' long by 2' high. The GreenLoxx wall consisted of sock, geogrid and Gripple anchors, with the anchors hidden under the turf. Monster Tree Services worked with a local environmental department for the county to determine what native species would be most successful in the growth of the wall. With minimal land disturbance and a new, green slope, the native animals were able to regain access into the uplands and the customer was able to save their backyard.
