PROJECT PROFILE

PROJECT: RESIDENTIAL CANAL

LOCATION: BOCA RATON, FL

APPLICATION: BANK STABILIZATION

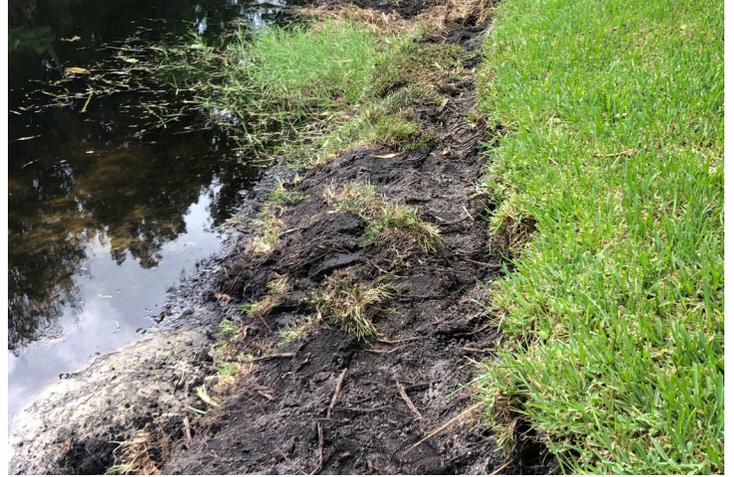
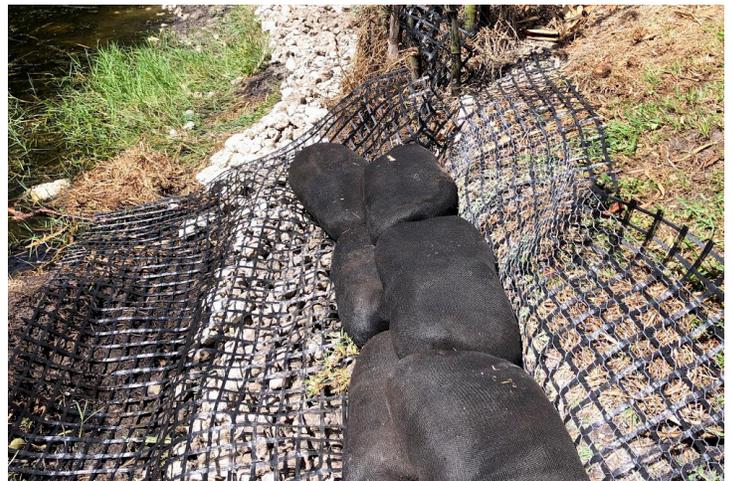
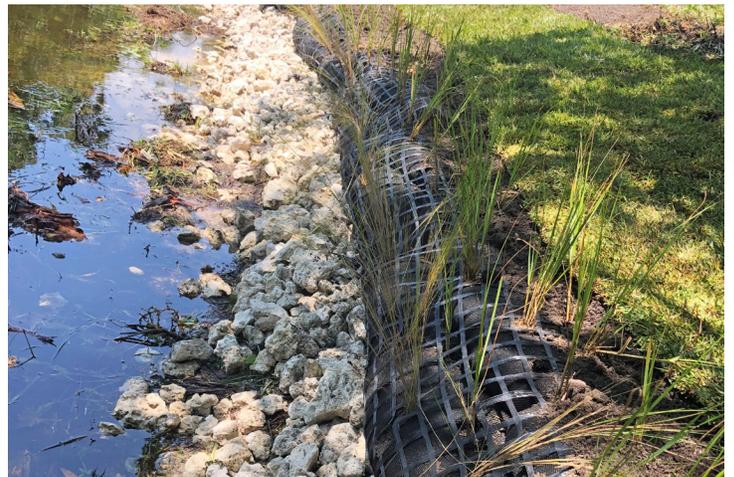
Success: The final, finished wall was 130' long by 2' high. The GreenLoxx wall consisted of GroSoxx®, geogrid and soil anchors, with the anchors hidden under the turf. Monster Tree Services worked with a local environmental department for the county to determine what native species would be most successful in the growth of the wall. With minimal land disturbance and a new, green slope, the native animals were able to regain access into the uplands and the customer was able to save their backyard.

Solution: Filtrex came down to inspect the site with Monster Tree Services and determine the best approach. Filtrex helped install a GreenLoxx Vegetated Slope Facing (VSF) system that was flat enough that the turtles could still climb up the slope and into the backyard. Because the base of the canal was soft and muddy, native limestone was placed at the base of the wall. This limestone base was created so the wall had something sturdy to sit on top of. Then, 16-24" of wall was built out to stabilize the slope, stopping the erosion and preventing further erosion from happening. Trees and other vegetation were in danger of falling into the canal due to the severe erosion and all were saved and incorporated into the new wall system and landscape.

A unique and additional problem occurred during the building of this wall. Iguanas, an invasive species to Florida, often dig up earth and Filtrex, Monster Tree Services and the customer were concerned with the new wall being dug up. After doing some additional research, a technique was found that was used in other areas of the United States to stop muskrats from digging up new walls. Galvanized chicken wire was placed under the wall system to deter iguanas from digging the wall up.
